KOMPSAT-5 Geolocation Accuracy Analysis with Mongolia and CEOS Calibration Site

19 Nov 2019

Korea Aerospace Research Institute
Horyung Jeong, Donghyun Kim, Dochul
Yang and Donghan Lee

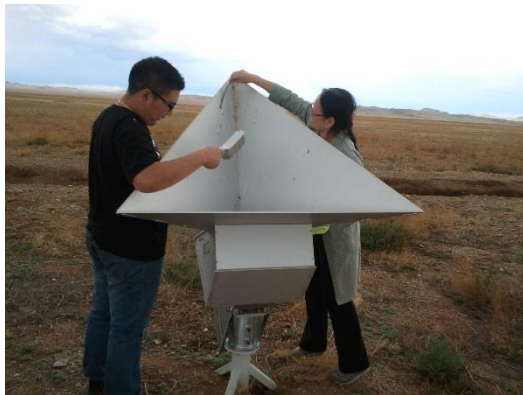
CR for High-Resolution Mode

- Introduction about Mongolia CAL Site for KOMPSAT-5
 - 52 CRs consisting of 20 ST and 32 HR CR are installed in Mongolia CAL site
 - Background level of Mongolia is very low and it is very suitable for SAR calibration site
 - No artificial buildings and structures exist around Mongolia calibration site

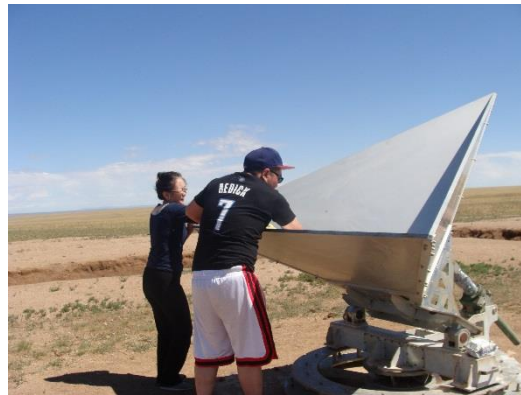
CR for Standard Mode

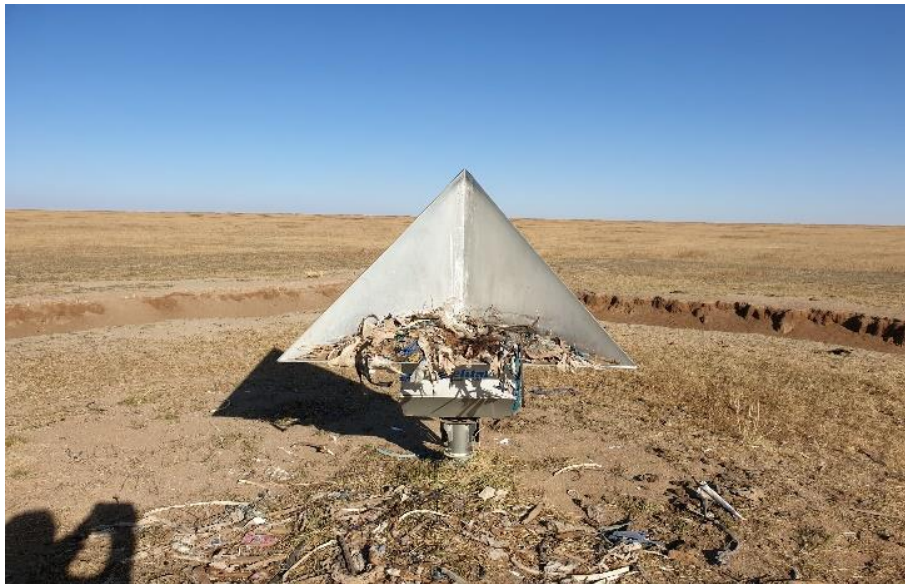
Before Cleaning

- KARI contract with NRSC(National Remote Sensing Center), Mongolia national institute, to maintain optic and SAR CAL targets every year
- Main activities for Mongolia CR
 - **Cleaning CR surface**
 - **Checking and adjusting CR elevation and azimuth angle to point K5 orbit**
 - **Repairing or replacing CR parts (if needed)**

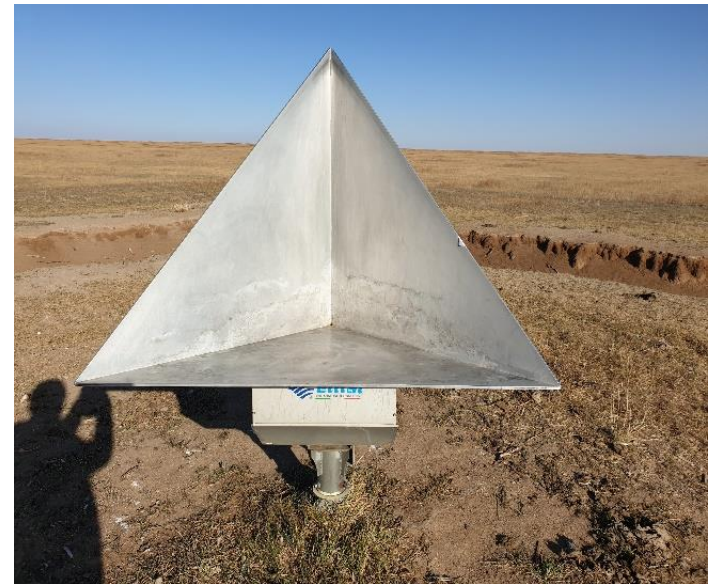
After Cleaning

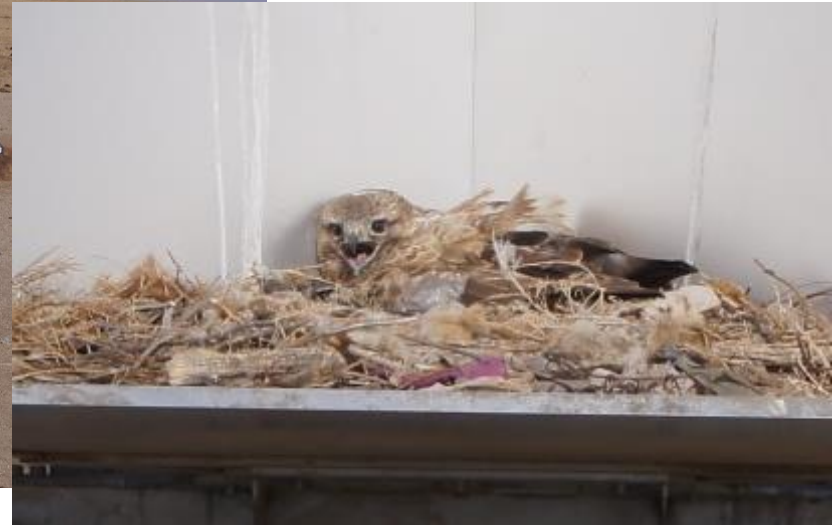
- **Special Case to Degrade CR Impulse Response**
 - Bird nest on CR plate
 - Cleaning activity was performed after young bird upbringing was completed

ST15A CR (before maintenance)

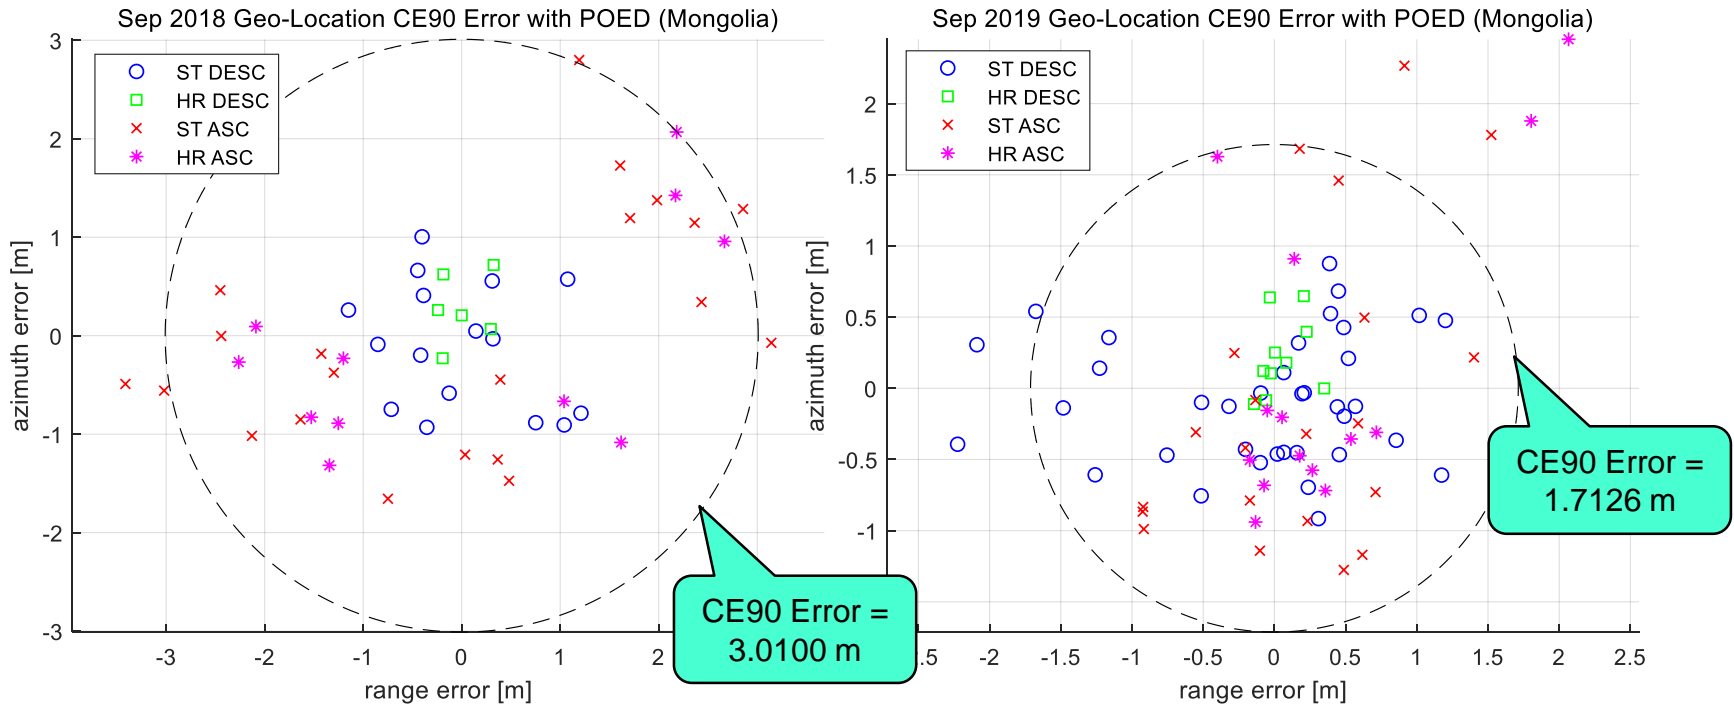
- Geolocation measured in Sep 2018 is slightly large because of heavy rain on Mongolia site
- However, CE90 error was recovered in Sep 2019 after CR condition becomes normal

K5 geolocation from Mongolia
CR, Sep 2018

K5 geolocation from Mongolia
CR, Sep 2019

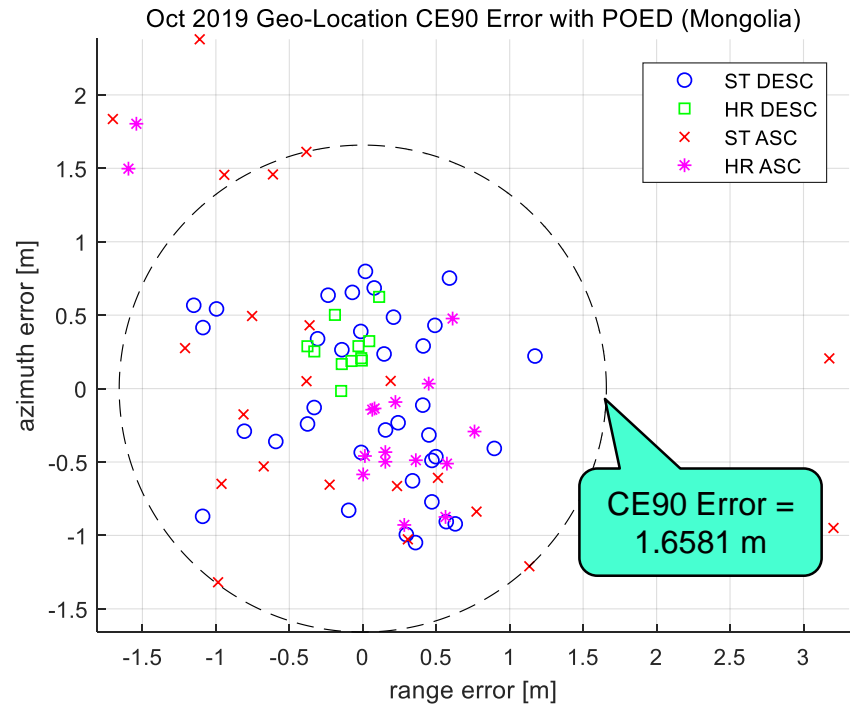
- CE90 error in Oct 2019 maintained as that of Oct 2018
- Every October month is recommended time to survey CRs because the weather is clear and little rain

K5 geolocation from Mongolia
CR, Oct 2019

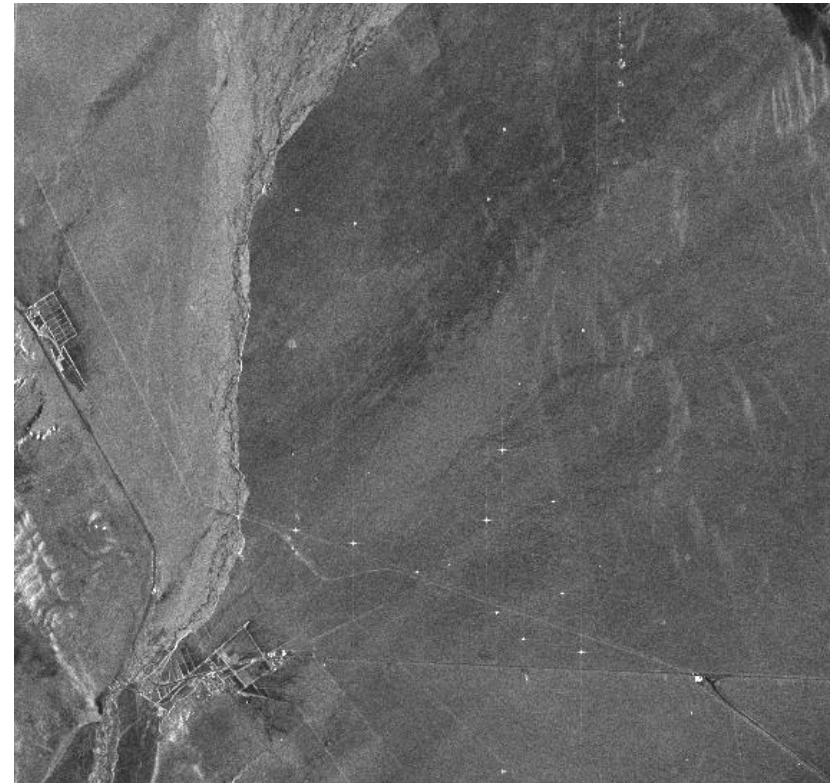
- Imaging time for measurement : from Aug to Oct 2019
- Number of CRs in the site : 14
- Summary of target information

Argentina CR image acquired in 23/Oct/2019

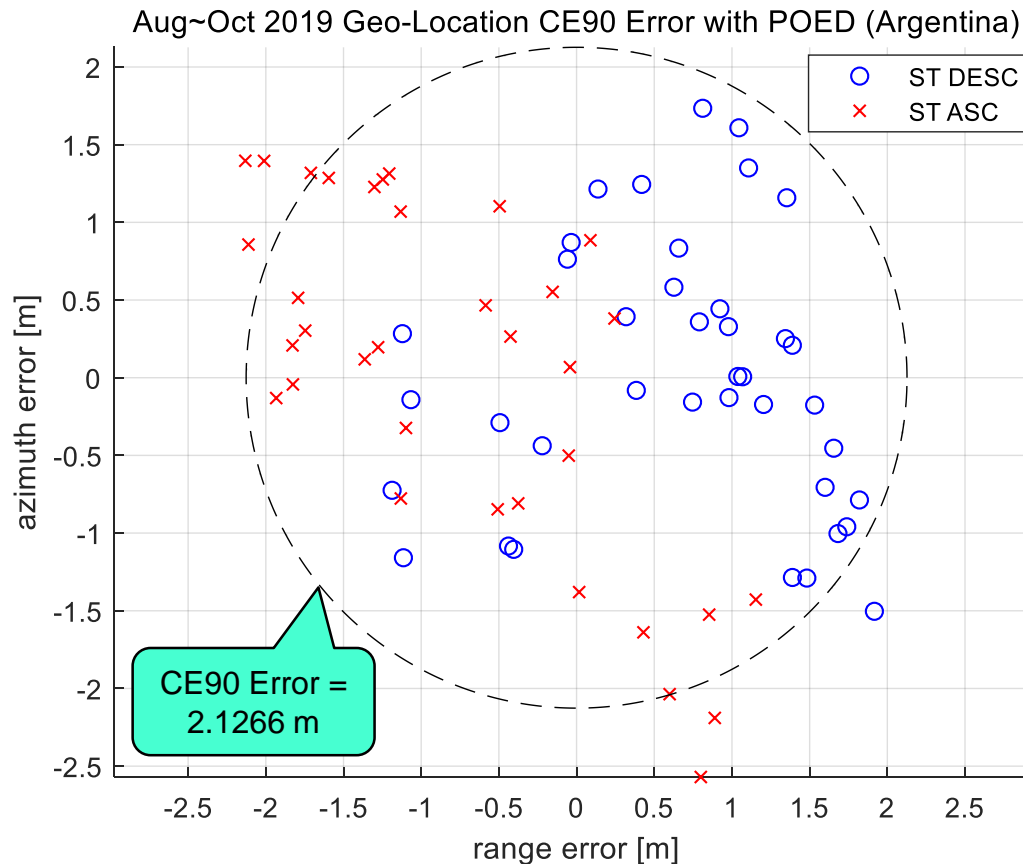
- Geolocation of ST mode was measured
- CE90 is about 2.1266 m and it is similar to Mongolia measurement

K5 geolocation from Argentina CR, Aug~Oct 2019

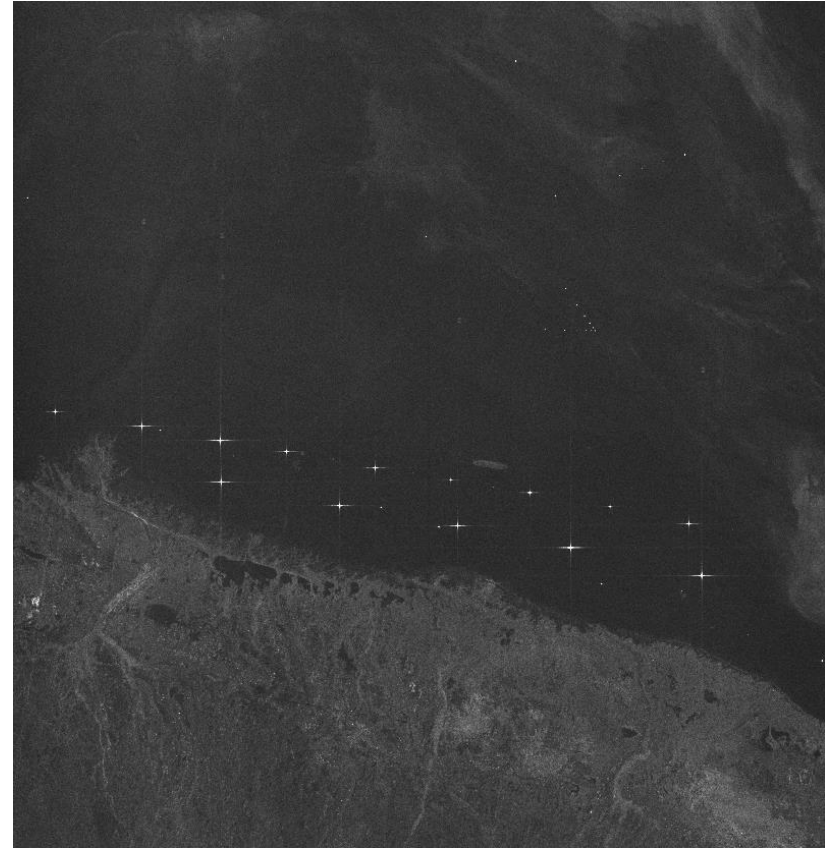
- Imaging time for measurement : from Aug to Oct 2019
- Number of CRs in the site : 35
- Summary of target information

Rosamond CR image acquired in 11/Oct/2019

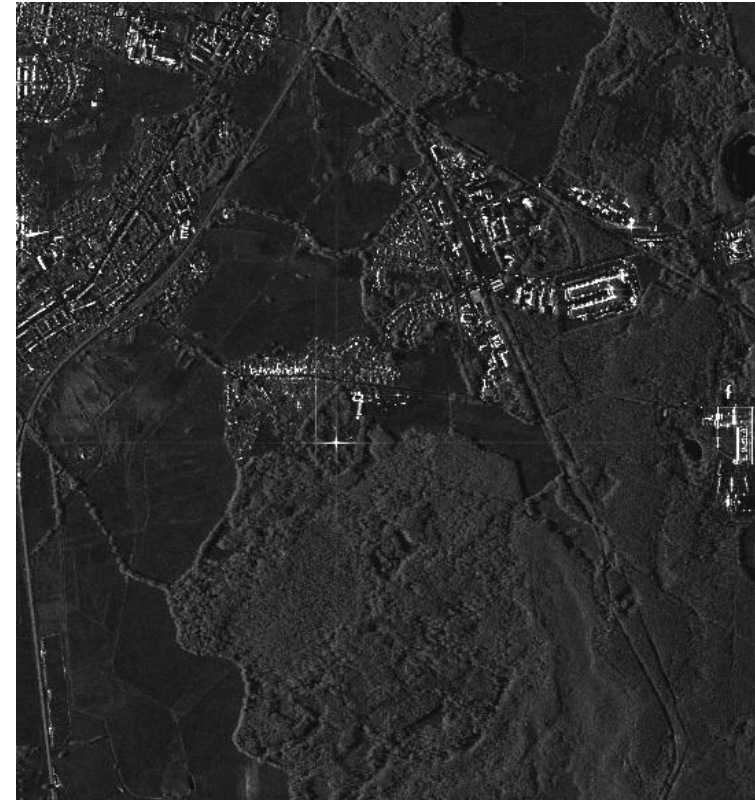
- Imaging time for measurement : from Aug to Oct 2019
- Number of CRs in the site : 4
- Summary of target information

Germany CR image acquired in 20/Oct/2019
