# GOME-1 CALIBRATION LAMP ANOMALY INVESTIGATION

ERSE-SPPA-EOAD-TN-02-0005

Technical Note

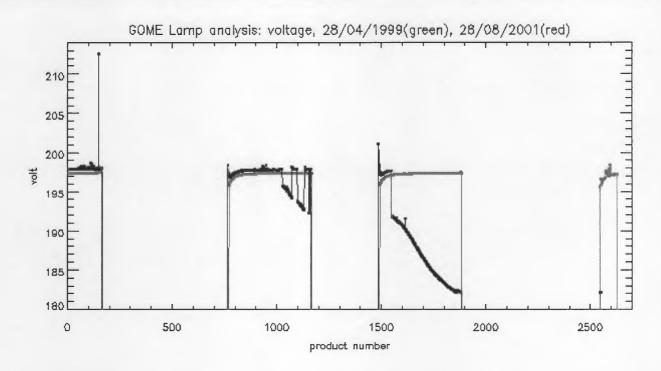
Figure 1 shows the comparison of the voltage of the calibration lamp during a nominal operation (April 1999) with an erroneous lamp calibration sequence observed in August 2001. The Lamp Failure flag was set after product (data record) ~2600, the calibration data records before can be used for the analysis of the calibration lamp problem.

The comparison with the nominal case in 1999 shows that for the first sequence, immediately after ignition the lamp performance is nominal in both cases. In contrast to earlier anomalies, the nominal voltage of 198 Volt is actually reached at product 800 of the anomalous sequence. This corresponds to 45 seconds after ignition. The data from August 2001 subsequently show three steep decreases in voltage, the first two followed by a recovery, the last one ending with the end of the first calibration sequence at product 1170. After each recovery, the voltage drops to a value equal to the last values prior to that recovery.

The second anomalous sequence also starts with nominal voltage increase which is interrupted after 60 products by a steep decrease to 192 Volts, which is equal to the last anomalous values of the first sequence. In this sequence, no recovery is observed. In stead the voltage continues to decrease to 182 Volts.

The third anomalous sequence starts off at this same value of 182 Volts. This value is so far below the nominal value that the on-board software considers this calibration lamp ignition to have failed. The lamp is switched off after 10 seconds and the lamp failure flag is set.

Figure 1: Comparison of Voltage. Nominal case plotted in green, data with lamp failure in red

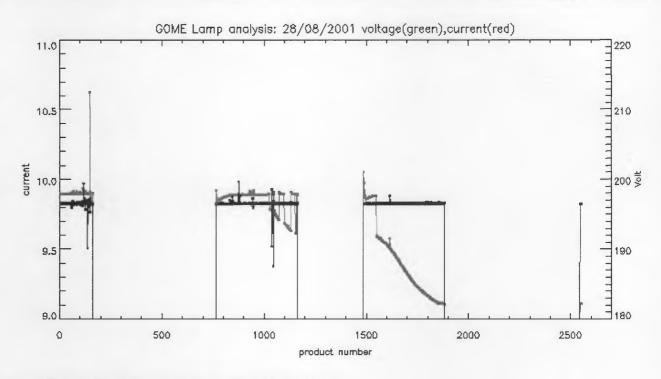
During the anomalous voltage reduction intervals, the current stabilisation of the lamp remains effective and with few exceptions the current remains constant.

Prior to the first complete sequence visible in figure 2, the last part of a nominal sequence is visible in which a strong current spike is present that corresponds to a voltage spike.

Figure 2: voltage and current in comparison (28/08/2001)

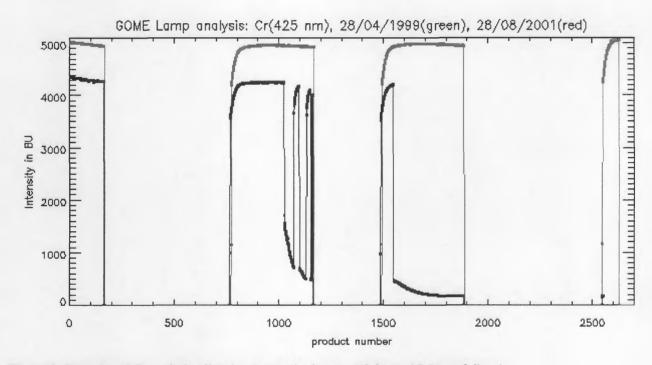
From Figures 3-5 the behaviour of the emission lines from the different elements of the hollow cathode gas discharge lamp can be seen. Cr, Pt and Ne decrease all steadily in intensity and at the same time the lamp voltage decreases to  $\sim$ 182 V.

Comparing the intensities of the different emission lines (Figures 3-5), it results that the intensities of Pt and Cr of dataset year 1999 are higher than the ones of August 2001. However for the intensity of the Ne emission line it is the contrary. This difference is consistent with the study results of TPD that show that metal line intensities degrade faster than Ne line intensities (see study TPD [2]).

Figure 3: Intensity of Cr emission line (green nominal case, red data with lamp failure)

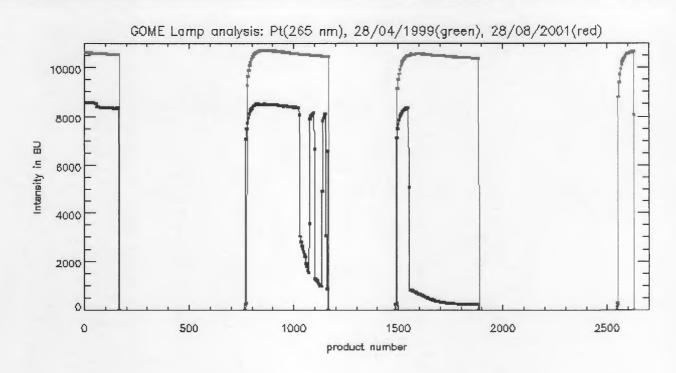
Figure 4: Intensity of Pt emission line (green nominal case, red data with lamp failure)

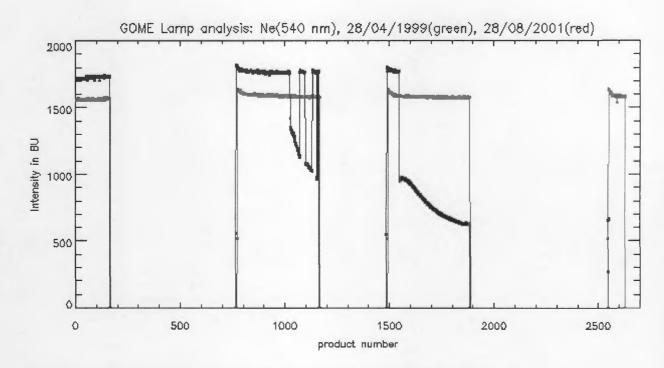
Figure 5: Intensity of Ne emission line (green nominal case, red data with lamp failure)

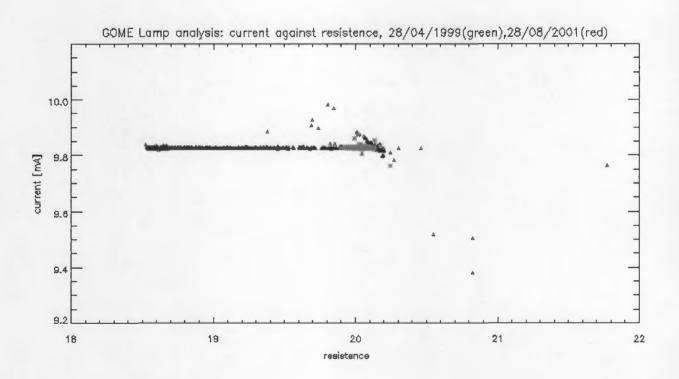
During the anomalous voltage reduction intervals, the current stabilisation of the lamp remains effective and with few exceptions the current remains constant. Only during the nominal part of the sequence is the characteristic 'negative resistance' behaviour present: slight increases in current that occur within the margins of the current stabilisation process are the consequences of excessive voltage correction, immediately resulting in reduction of resistance as additional electrons are liberated.

Figure 6: current versus resistence

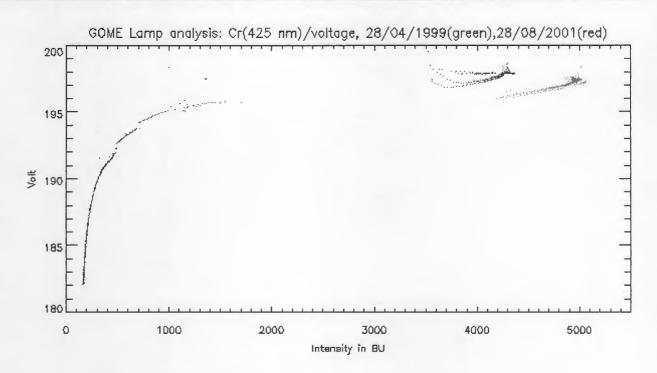
For the metal emission lines, the voltage cycles to stabilize the current can be observed at high voltage, but only in the nominal case does the intensity increase linearly with voltage

Figure 7: Intensity of Cr emission line in relation to lamp voltage (nominal case plotted in green; anomalous data plotted red)

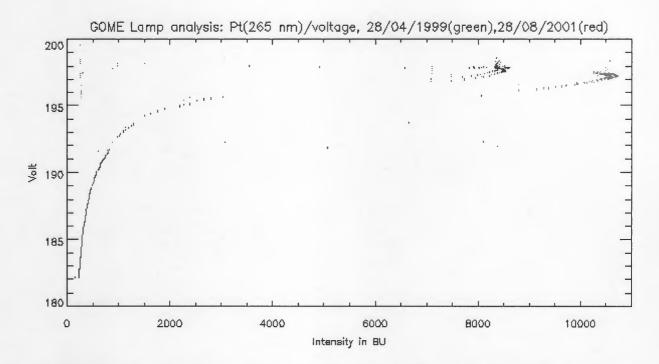
Figure 8: Intensity of Pt emission line in relation to lamp voltage (nominal case plotted in green; anomalous data plotted red)

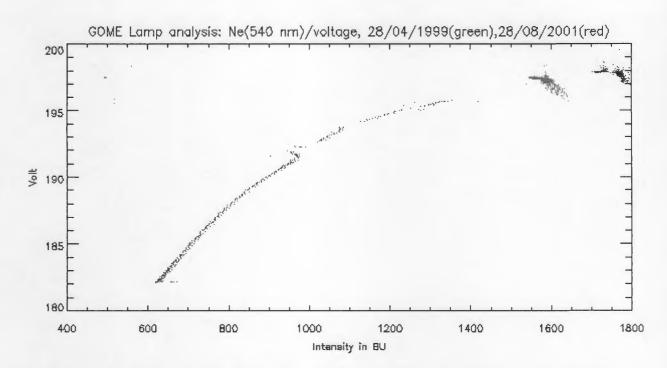
Figure 9: Intensity of Ne emission line in relation to lamp voltage (nominal case plotted in green; anomalous data plotted red)

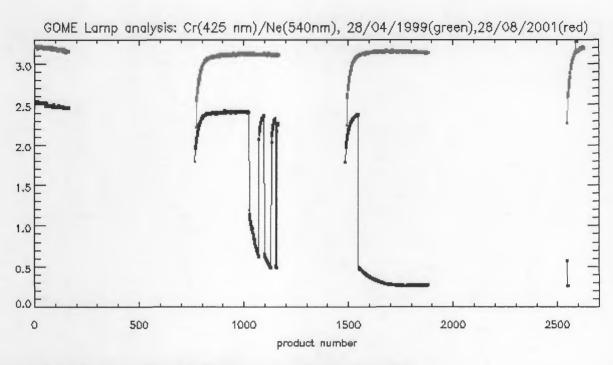
- A gradual deviation of the ratio of the anomalous calibration compared to the nominal case. This is an indication of thermal effects: in the anomalous case the decrease of voltage causes reduction of temperature and the emission line ratio will change since the lines have different wavelengths
- Unexplained peaks in the ratio occur at the onset of anomalies

Figure 10: Intensity of Cr emission line divided by intensity of Ne emission line

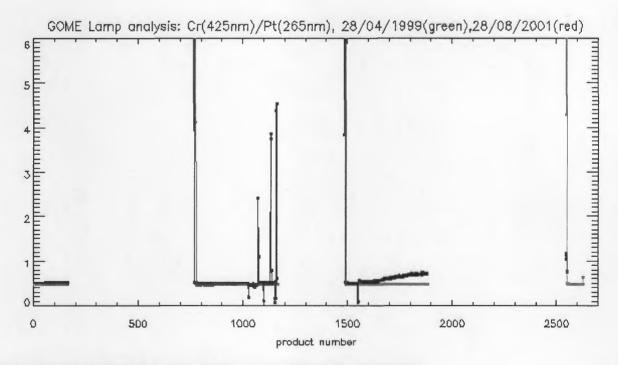
Figure 11: Intensity of Cr emission line divided by intensity of Pt emission line

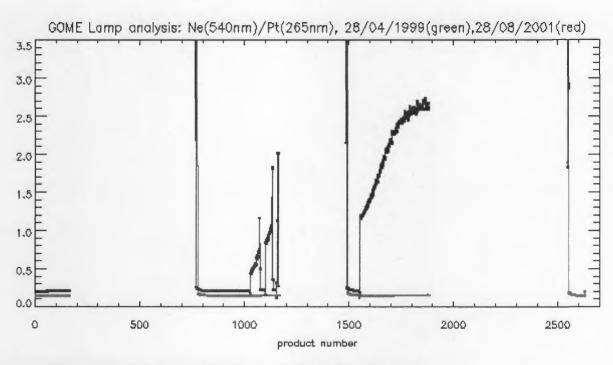
Figure 12: Intensity of Ne emission line divided by intensity of Pt emission line
